Manhole Inspection Summary

Manhole # S35AA_010MH

Insp Date: **8/21/08 1:56 PM**

Location Address: **211 guilford ave**

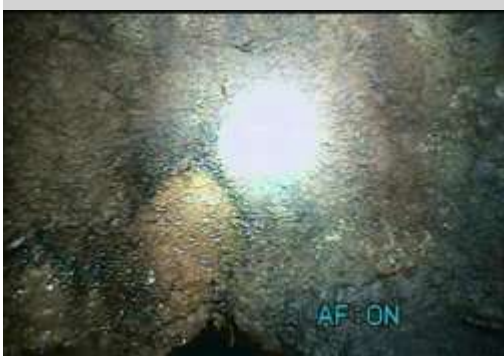
Defect 3

Infiltration: ☐ None ☐ Joint ☐ Cracks ☐ Mortar ☐ Roots ☒ **Wall**

infiltration in barrel

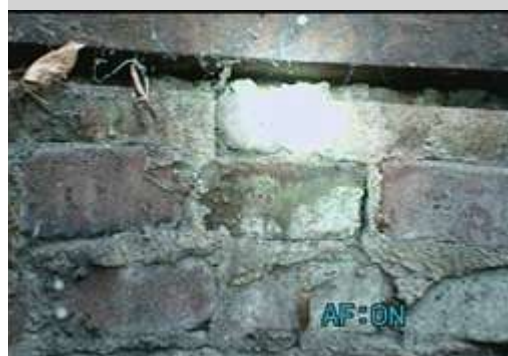
Defect 2

Condition: ☐ Sound ☐ Cracked ☐ Root Intrusion ☒ **Loose Brick** ☒ **Deteriorated**

chimney cond loose bricks, deterioration

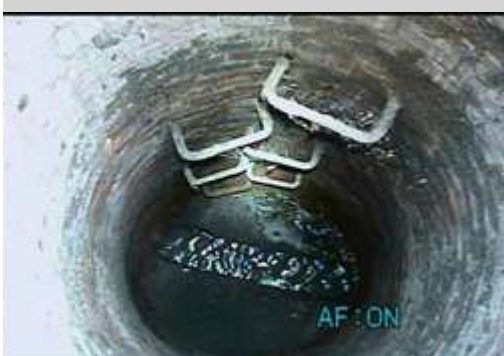
Defect 1

Steps Count: **6** Missing: **0** ☒ **Corroded**

steps

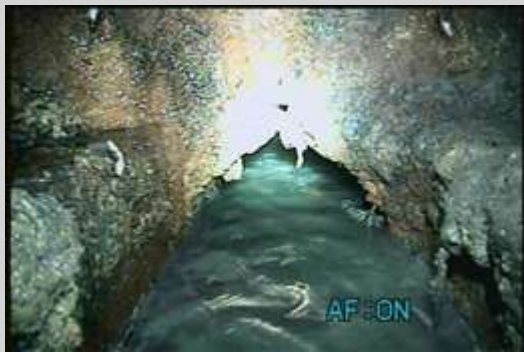
12 O'Clock Outflow

8 in. Circular Gravity Sewer
Pipe Out @ 12 O'Clock

Invert Depth: 11.75 (ft.) Flow Characteristics: **Slow**

Infiltration: **None** Pipe Seal Cond: **Unknown**

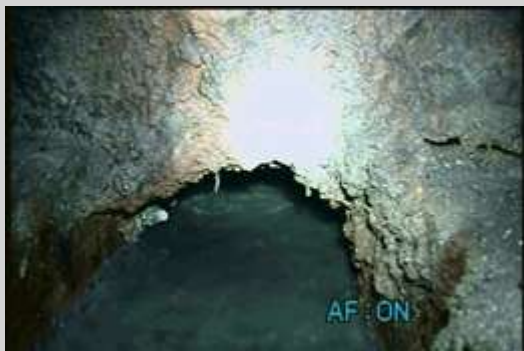
6 O'Clock Inflow

8 in. Circular Gravity Sewer
Pipe In @ 6 O'Clock

Invert Depth: 11.60 (ft.) Flow Characteristics: **Slow**

Infiltration: **None** Pipe Seal Cond: **Unknown**
